COLUMBIA

ACCIDENT INVESTIGATION REPORT

REPORT VOLUME 1
AUGUST 2003

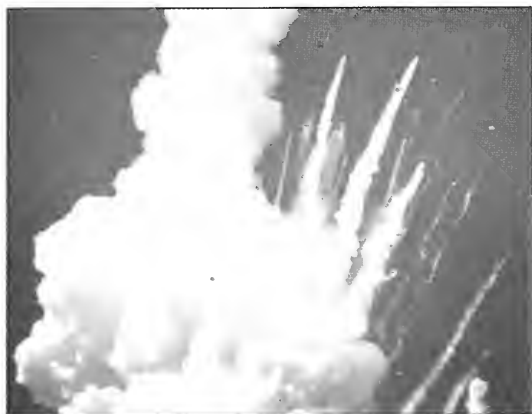
Figure 1.5-1. the Space Shuttle Challenger was lost during ascent on January 28, 1986, when an O-ring and seal in the right Solid Rocket Booster failed.

The Rogers Commission report, issued on June 6, 1986, recommended a redesign and recertification of the Solid Rocket Motor joint and seal and urged that an independent body oversee its qualification and testing. The report concluded that the drive to declare the Shuttle operational had put enormous pressures on the system and stretched its resources to the limit. Faulting NASA safety practices, the Commission also called for the creation of an independent NASA Office of Safety, Reliability, and Quality Assurance, reporting directly to the NASA Administrator, as well as structural changes in program management.²⁰ (The Rogers Commission findings and recommendations are discussed in more detail in Chapter 5.) It would take NASA 32 months before the next Space Shuttle mission was launched. During this time, NASA initiated a series of longer-term vehicle upgrades, began the construction of the Orbiter *Endeavour* to replace *Challenger*, made significant organizational changes, and revised the Shuttle manifest to reflect a more realistic flight rate.

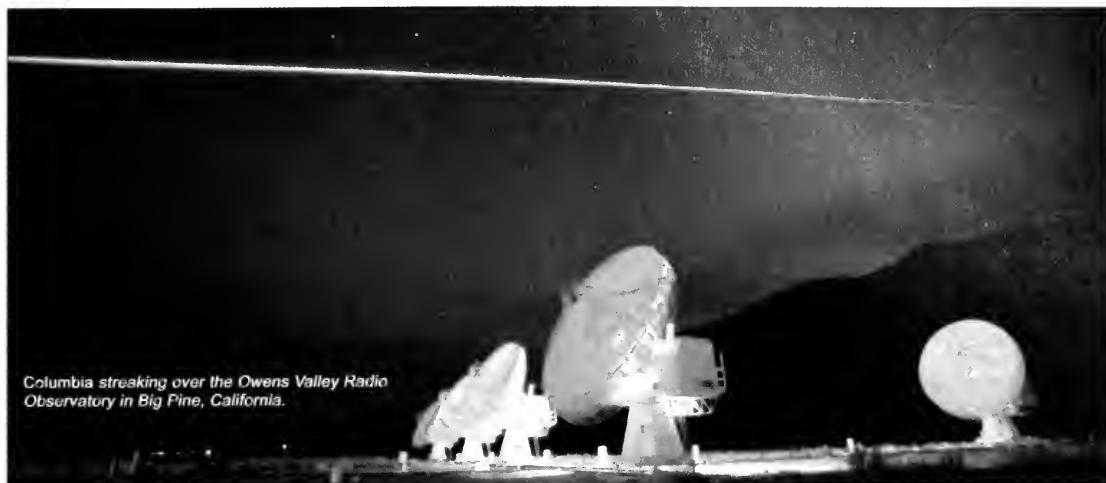
Columbia streaking over the Owens Valley Radio Observatory in Big Pine, California.

Now crossing California, the Orbiter appeared to observers on the ground as a bright spot of light moving rapidly across the sky. Signs of debris being shed were sighted at 8:53:46 a.m. (EI+577), when the superheated air surrounding the Orbiter suddenly brightened, causing a noticeable streak in the Orbiter's luminescent trail. Observers witnessed another four similar events during the following 23 seconds, and a bright flash just seconds after *Columbia* crossed from California into Nevada airspace at 8:54:25 a.m. (EI+614), when the Orbiter was traveling at Mach 22.5 and 227,400 feet. Witnesses observed another 18 similar events in the next four minutes as *Columbia* streaked over Utah, Arizona, New Mexico, and Texas.

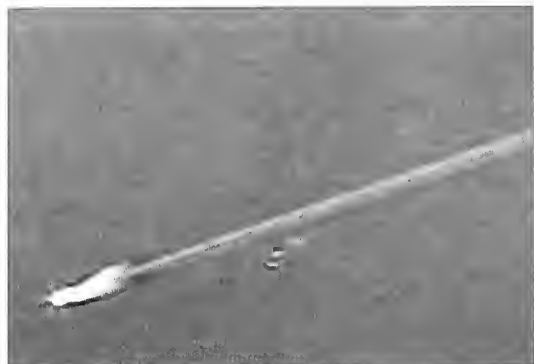
The Orbiter has a large glowing field surrounding it in this view taken from Mesquite, Texas, looking south.

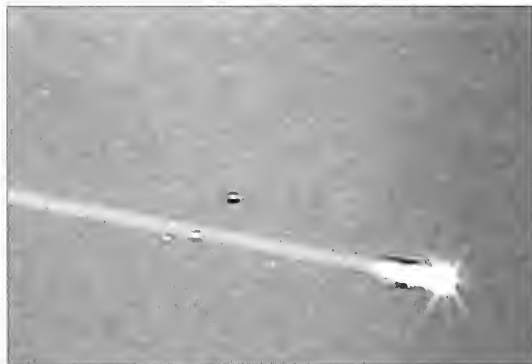
Taken at the same time as the photo at left, but from Hewitt, Texas, looking north.

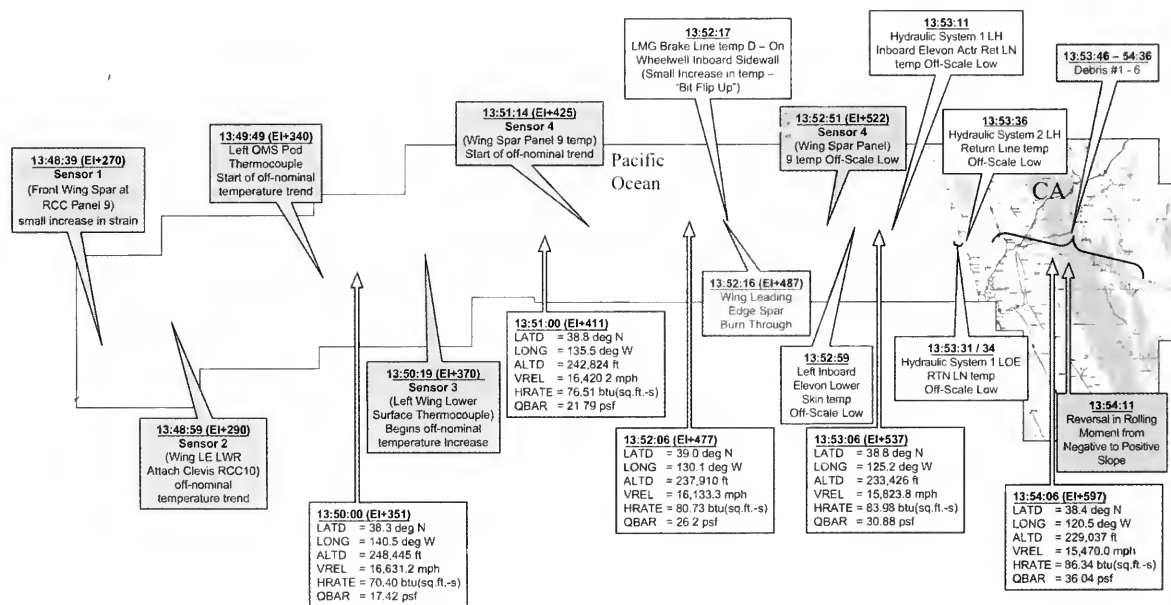
At 8:48:39 a.m. (EI+270), a sensor on the left wing leading edge spar showed strains higher than those seen on previous *Columbia* re-entries. This was recorded only on the Modular Auxiliary Data System, and was not telemetered to ground controllers or displayed to the crew (see Figure 2.6-1).

Figure 2.6-1. This simplified timeline shows the re-entry path of Columbia on February 1, 2003. The information presented here is a composite of sensor data telemetered to the ground combined with data from the Modular Auxiliary Data System recorder recovered after the accident. Note that the first off-nominal reading was a small increase in a strain gauge at the front wing spar behind RCC panel 9-left. The chart is color-coded: blue boxes contain position, attitude, and velocity information; orange boxes indicate when debris was shed from the Orbiter; green boxes are significant aerodynamic control events; gray boxes contain sensor information from the Modular Auxiliary Data System; and yellow boxes contain telemetered sensor information. The red boxes indicate other significant events.

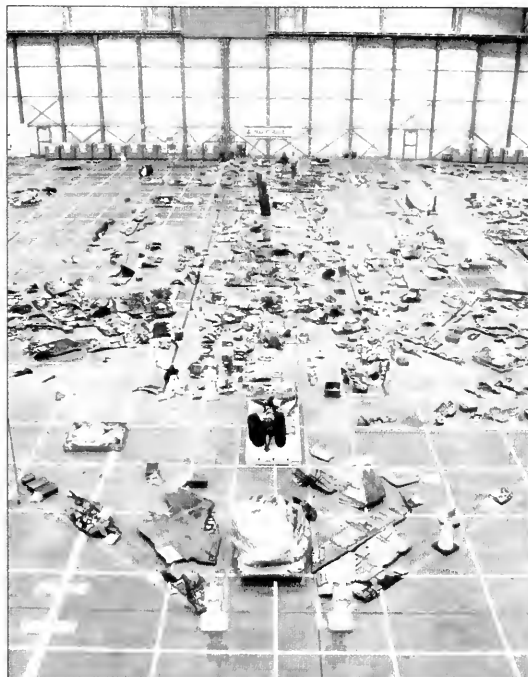
Figure 2.7-4. Recovered debris was returned to the Kennedy Space Center where it was laid out in a large hangar. The tape on the floor helped workers place each piece near where it had been on the Orbiter.

The debris collected (see Figure 2.7-4) by searchers aided the investigation in significant ways. Among the most important finds was the Modular Auxiliary Data System recorder that captured data from hundreds of sensors that was not telemetered to Mission Control. Data from these 800 sensors, recorded on 9,400 feet of magnetic tape, provided investigators with millions of data points, including temperature sensor readings from *Columbia's* left wing leading edge. The data also helped fill a 30-second gap in telemetered data and provided an additional 14 seconds of data after the telemetry loss of signal.

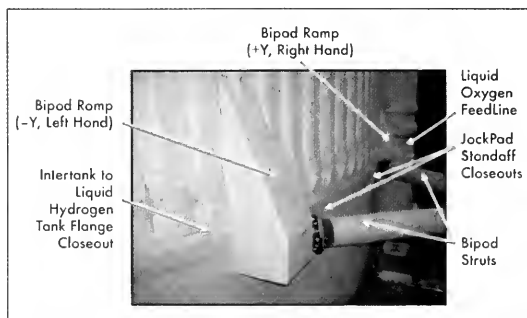
Figure 3.2-2. The exterior of the left bipod attachment area showing the foam ramp that came off during the ascent of STS-107.

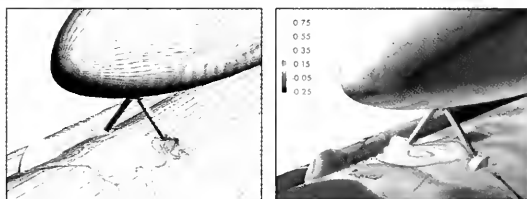
Figure 3.2-5. Computational Fluid Dynamics was used to understand the complex flow fields and pressure coefficients around bipod strut. The flight conditions shown here approximate those present when the left bipod foam ramp was lost from External Tank 93 at Mach 2.46 at a 2.08-degree angle of attack.

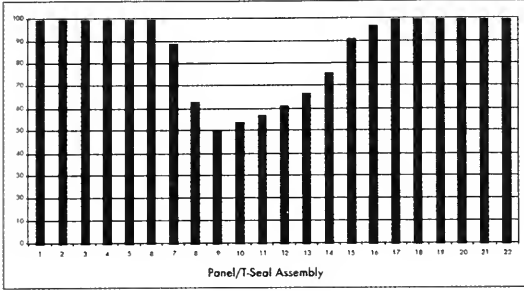
For the first five missions of *Columbia*, the RCC components were not coated with Type A sealant, and had shorter mission service lives than the RCC components on the other Orbiters. (*Columbia*'s panel 9 has the shortest mission service life of 50 flights as shown in Figure 3.3-4.) The predicted life for panel/T-seals 7 through 16 range from 54 to 97 flights.

Figure 3.3-4. The expected mission life for each of the wing leading edge RCC panels on Columbia. Note that panel 9 has the shortest life expectancy.

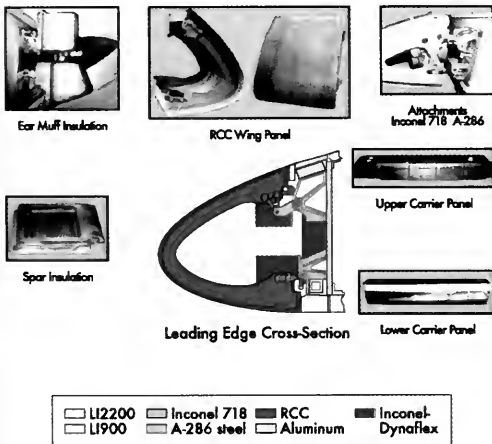
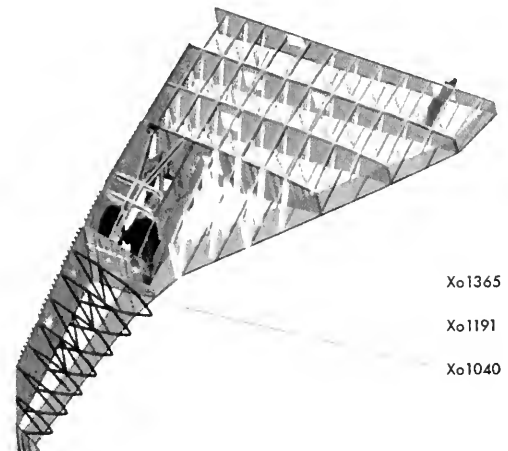
The Wing Leading Edge Structural System on Columbia.

The mid-wing area on the left wing, behind where the breach occurred, is supported by a series of trusses, as shown in red in the figure below. The mid-wing area is bounded in the front and back by the Xo1040 and Xo1191 cross spars, respectively. The numerical designation of each spar comes from its location along the Orbiter's X-axis; for example, the Xo1040 spar is 1,040 inches from the zero point on the X-axis. The cross spars provide the wing's structural integrity. Three major cross spars behind the Xo1191 spar provide the primary structural strength for the aft portion of the wing. The inboard portion of the mid-wing is the outer wall of the left wheel-well, and the outboard portion of the mid-wing is the wing leading edge spar, where the RCC panels attach.

The major internal support structures in the mid-wing are constructed from aluminum alloy. Since aluminum melts at 1,200 degrees Fahrenheit, it is likely these truss tubes in the mid-wing were destroyed and wing structural integrity was lost.

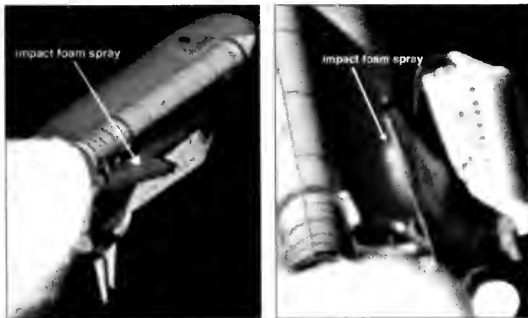
Figure 3.4-1 (color enhanced and "de-blurred" by Lockheed Martin Gaithersburg) and Figure 3.4-2 (processed by the National Imagery and Mapping Agency) are samples of the type of visual data used to establish the time of the impact (81.9 seconds), the altitude at which it occurred (65,860 feet), and the object's relative velocity at impact (about 545 mph relative to the Orbiter).

A 35-mm film camera, E212, which recorded the foam strike from 17 miles away, and video camera E208, which recorded it from 26 miles away, provided the best of the available evidence. Analysis of this visual evidence (see Figures 3.4-1 and 3.4-2) along with computer-aided design analysis, refined the potential impact area to less than 20 square feet in RCC panels 6 through 9 (see Figure 3.4-3), including a portion of the corresponding carrier panels and adjacent tiles. The investigation image analysis team found no conclusive visual evidence of post-impact debris flowing over the top of the wing.

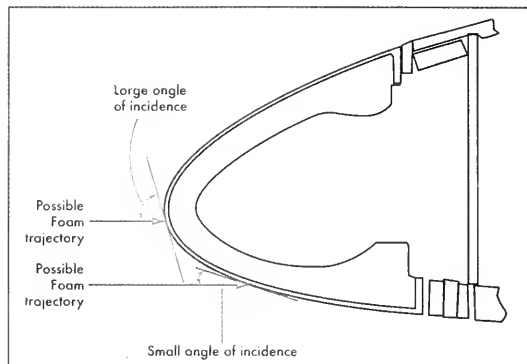
Image analysis determined that the foam was moving almost parallel to the Orbiter's fuselage at impact, with about a five-degree angle upward toward the bottom of the wing and slight motion in the outboard direction. If the foam had hit the tiles adjacent to the leading edge, the angle of incidence would have been about five degrees (the angle of incidence is the angle between the relative velocity of the projectile and the plane of the impacted surface). Because the wing leading edge curves, the angle of incidence increases as the point of impact approaches the apex of an RCC panel. Image and transport analyses estimated that for impact on RCC panel 8, the angle of incidence was between 10 and 20 degrees (see Figure 3.4-4).⁹ Because the total force delivered by the impact depends on the angle of incidence, a foam strike near the apex of an RCC panel could have delivered about twice the force as an impact close to the base of the panel.

Figure 3.4.4. This drawing shows the curve of the wing leading edge and illustrates the difference the angle of incidence has on the effect of the foam strike.

The precise impact location of the foam determined the impact angle because the debris was moving almost parallel to the Orbiter's fuselage at impact. Tile areas would have been hit at very small angles (approximately five degrees), but the curvature of the leading edge created angles closer to 20 degrees (see Figure 3.4-4).

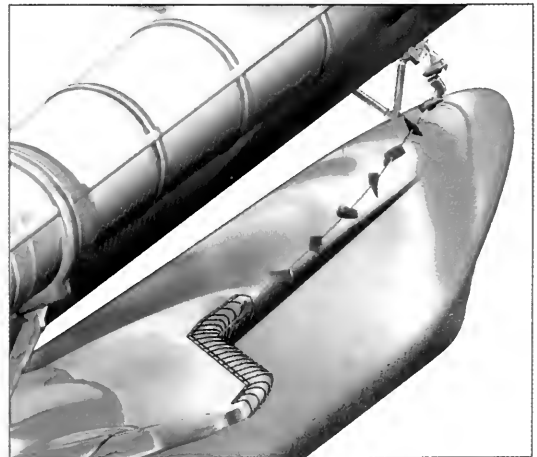
Figure 3.4-6. These are the results of a trajectory analysis that used a computational fluid dynamics approach in a program called CART-3D, a comprehensive (six-degree-of-freedom) computer simulation based on the laws of physics. This analysis used the aerodynamic and mass properties of bipod ramp foam, coupled with the complex flow field during ascent, to determine the likely position and velocity histories of the foam.

The undetermined and yet certainly irregular shape of the foam introduced substantial uncertainty about its estimated aerodynamic characteristics. Appendix D.8 contains an independent analysis conducted by the Board to confirm that the estimated range of ballistic coefficients of the foam in Figure 3.4-6 was credible, given the foam dimension results from the image analyses and the expected range of the foam density. Based on the results in Figure 3.4-7, the physical dimensions of the bipod ramp, and the sizes and shapes of the available barrels for the compressed-gas gun used in the impact test program described later in this chapter, the Board and the NASA Accident Investigation Team decided that a foam projectile 19 inches by 11.5 inches by 5.5 inches, weighing 1.67 pounds, and with a weight density of 2.4 pounds per cubic foot, would best represent the piece of foam that separated from the External Tank bipod ramp and was hit by the Orbiter's left wing. See Section 3.8 for a full discussion of the foam impact testing.

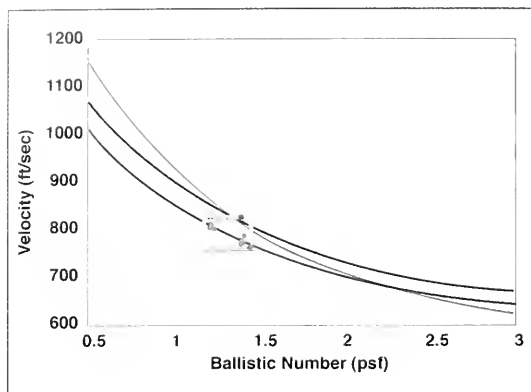
Figure 3.4-7. The results of numerous possible trajectories based on various assumed sizes, shapes, and densities of the foam. Either the foam had a slightly higher ballistic coefficient and the Orbiter struck the foam at a lower speed relative to the Orbiter, or the foam was more compact and the wing struck the foam at a higher speed. The "best fit" box represents the overlay of the data from the image analysis with the transport analysis computations. This data enabled a final selection of projectile characteristics for impact testing.

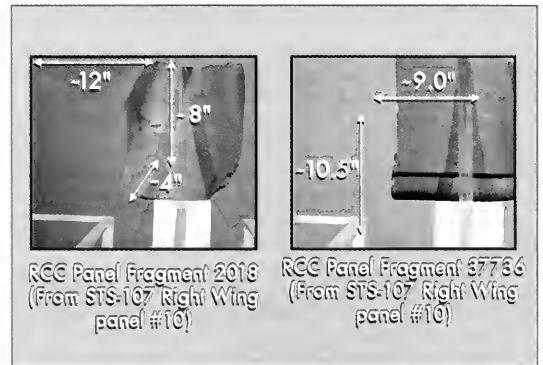
Figure 3.5-1. These representative RCC acreage pieces matched the radar cross-section of the Flight Day 2 object.

In the Advanced Compact Range at the Air Force Research Laboratory in Dayton, Ohio, analysts tested 31 materials from the Orbiter's exterior and payload bay. Additional supercomputer radar cross-section predictions were made for Reinforced Carbon-Carbon T-seals. After exhaustive radar cross-section analysis and testing, coupled with ballistic analysis of the object's orbital decay, only a fragment of RCC panel would match the UHF radar cross-section and ballistic coefficients observed by the Space Surveillance network. Such an RCC panel fragment must be approximately 140 square inches or greater in area to meet the observed radar cross-section characteristics. Figure 3.5-1 shows RCC panel fragments from *Columbia*'s right wing that represent those meeting the observed characteristics of object 2003-003B.¹⁰

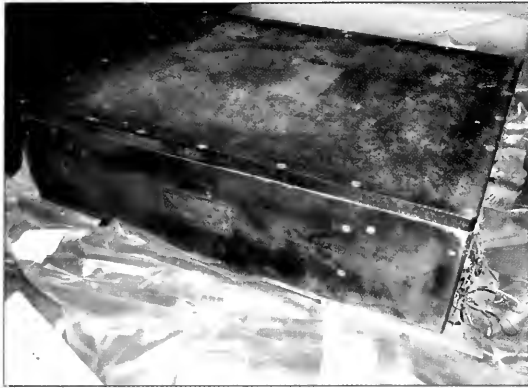
The Modular Auxiliary Data System is a supplemental instrumentation system that gathers Orbiter data for processing after the mission is completed. Inputs are almost exclusively physical sensor readings of temperatures, pressures, mechanical strains, accelerations, and vibrations. The Modular Auxiliary Data System usually records only the mission's first and last two hours (see Figure 3.6-1).

Figure 3.6-1. The Modular Auxiliary Data System recorder, found near Hemphill, Texas. While not designed to withstand impact damage, the recorder was in near-perfect condition when recovered on March 19, 2003.

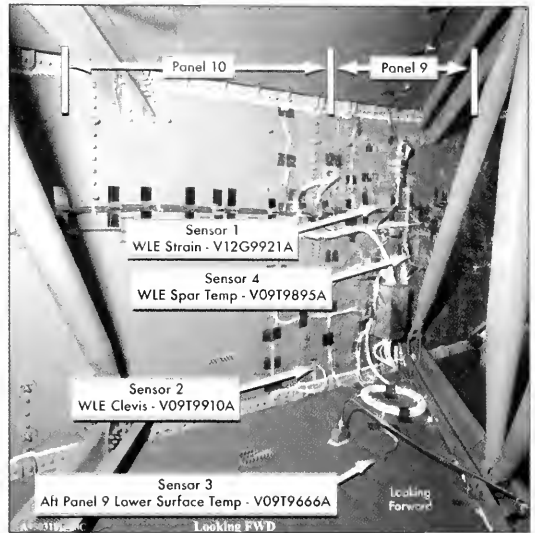
Figure 3.6-2. Location of sensors on the back of the left wing leading edge spar (vertical aluminum structure in picture). Also shown are the round truss tubes and ribs that provided the structural support for the mid-wing in this area.

or outside the wing leading edge spar near Reinforced Carbon-Carbon (RCC) panel 9-left, helped tell the story of what happened on the left wing of the Orbiter early in the re-entry. These four sensors were: strain gauge V12G9921A (Sensor 1), resistance temperature detector V09T9910A on the RCC clevis between panel 9 and 10 (Sensor 2), thermocouple V07T9666A, within a Thermal Protection System tile (Sensor 3), and resistance temperature detector V09T9895A (Sensor 4), located on the back side of the wing leading edge spar behind RCC panels 8 and 9 (see Figure 3.6-2).

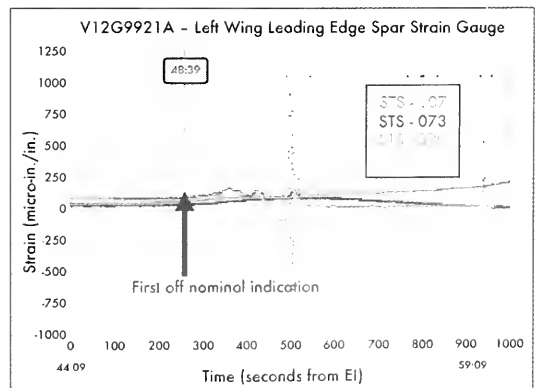
Figure 3.6-3. The strain gauge (Sensor 1) on the back of the left wing leading edge spar was the first sensor to show an anomalous reading. In this chart, and the others that follow, the red line indicates data from STS-107. Data from other Columbia re-entries, similar to the STS-107 re-entry profile, are shown in the other colors.

Sensor 1 provided the first anomalous reading (see Figure 3.6-3). From EI+270 to EI+360, the strain is higher than that on previous *Columbia* flights. At EI+450, the strain reverses, and then peaks again in a negative direction at EI+475. The strain then drops slightly, and remains constant and negative until EI+495, when the sensor pattern becomes unreliable, probably due to a propagating soft short, or “burn-through” of the insulation between cable conductors caused by heating or combustion. This strain likely indicates significant damage to the aluminum honeycomb spar. In particular, strain reversals, which are unusual, likely mean there was significant high-temperature damage to the spar during this time.

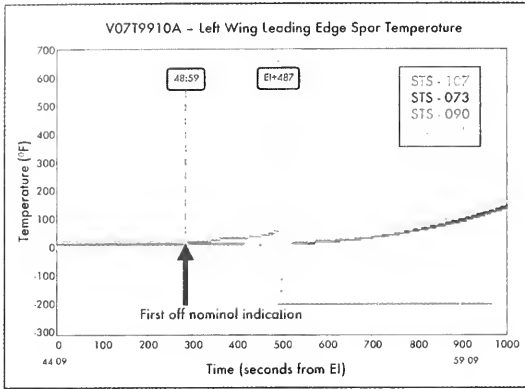
Figure 3.6.4. This temperature thermocouple (Sensor 2) was mounted on the outside of the wing leading edge spar behind the insulation that protects the spar from radiated heat from the RCC panels. It clearly showed an off-nominal trend early in the re-entry sequence and began to show an increase in temperature much earlier than the temperature sensor behind the spar.

left wing leading edge spar, recorded the beginning of a gradual and abnormal rise in temperature from an expected 30 degrees Fahrenheit to 65 degrees at EI+493, when it then dropped to “off-scale low,” a reading that drops off the scale at the low end of the sensor’s range (see Figure 3.6-4). Sensor 2, one of the first to fail, did so abruptly. It had indicated only a mild warming of the RCC attachment clevis before the signal was lost.

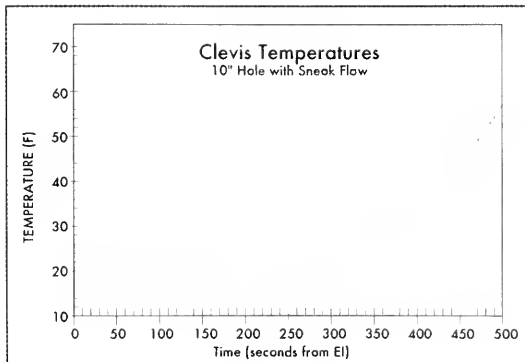
Figure 3.6.5. The analysis of the effect of a 10-inch hole in RCC panel 8 on Sensor 2 from EI to EI+500 seconds. The jagged line shows the actual flight data readings and the smooth line the calculated result for a 10-inch hole with some sneak flow of superheated air behind the spar insulation.

A series of thermal analyses were performed for different sized holes in RCC panel 8 to compute the time required to heat Sensor 2 to the temperature recorded by the Modular Auxiliary Data System. To heat the clevis, various insulators would have to be bypassed with a small amount of leakage, or “sneak flow.” Figure 3.6-5 shows the results of these calculations for, as an example, a 10-inch hole, and demonstrates that with sneak flow around the insulation, the temperature profile of the clevis sensor was closely matched by the engineering calculations. This is consistent with the same sneak flow required to match a similar but abnormal ascent temperature rise of the same sensor, which further supports the premise that the breach in the leading edge of the wing occurred during ascent. While the exact size of the breach will never be known, and may have been smaller or larger than 10 inches, these analyses do provide a plausible explanation for the observed rises in temperature sensor data during re-entry.

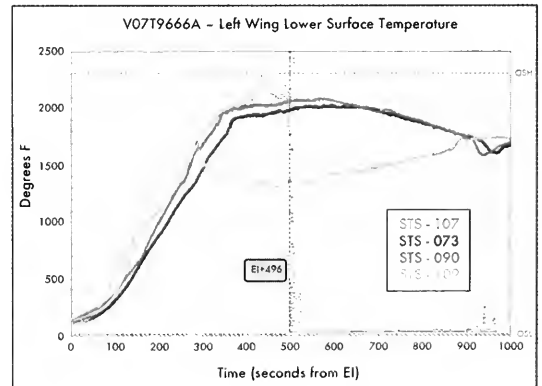
Figure 3.6.6. As early as EI+370, Sensor 3 began reading significantly higher than on previous flights. Since this sensor was located in a thermal tile on the lower surface of the left wing, its temperatures are much higher than those for the other sensors.

The readings of Sensor 3, which was in a thermal tile, began rising abnormally high and somewhat erratically as early as EI+370, with several brief spikes to 2,500 degrees Fahrenheit, significantly higher than the 2,000-degree peak temperature on a normal re-entry (Figure 3.6-6). At EI+496, this reading became unreliable, indicating a failure of the wire or the sensor. Because this thermocouple was on the wing lower surface, directly behind the junction of RCC panel 9 and 10, the high temperatures it initially recorded were almost certainly a result of air jetting through the damaged area of RCC panel 8, or of the normal airflow being disturbed by the damage. Note that Sensor 3 provided an external temperature measurement, while Sensors 2 and 4 provided internal temperature measurements.

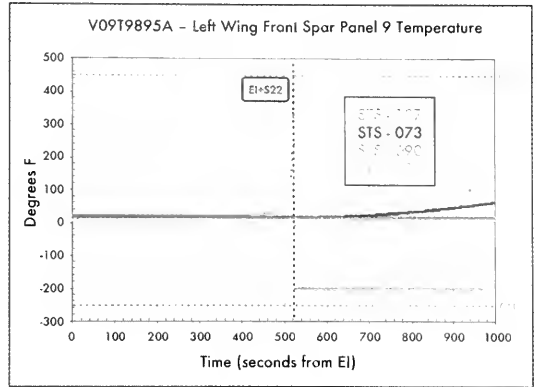
Sensor 4 also recorded a rise in temperature that ended in an abrupt fall to off-scale low. Figure 3.6-7 shows that an abnormal temperature rise began at EI+425 and abruptly fell at EI+525. Unlike Sensor 2, this temperature rise was extreme, from an expected 20 degrees Fahrenheit at EI+425 to 40 degrees at EI+485, and then rising much faster to 120 degrees at EI+515, then to an off-scale high (a reading that climbs off the scale at the high end of the range) of 450 degrees at EI+522. The failure pattern of this sensor likely indicates destruction by extreme heat.

Figure 3.6-7. Sensor 4 also began reading significantly higher than previous flights before it fell off-scale low. The relatively late reaction of this sensor compared to Sensor 2, clearly indicated that superheated air started on the outside of the wing leading edge spar and then moved into the mid-wing after the spar was burned through. Note that immediately before the sensor (or the wire) fails, the temperature is at 450 degrees Fahrenheit and climbing rapidly. It was the only temperature sensor that showed this pattern.

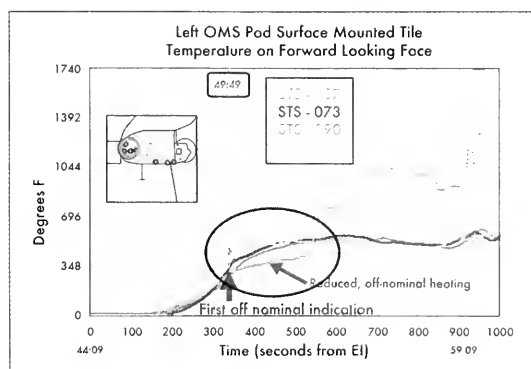
Figure 3.6-9. Orbital Maneuvering System (OMS) pod heating was initially significantly lower than that seen on previous Columbia missions. As wing leading edge damage later increased, the OMS pod heating increased dramatically. Debris recovered from this area of the OMS pod showed substantial pre-breakup heat damage and imbedded drops of once-molten metal from the wing leading edge in the OMS pod thermal tiles.

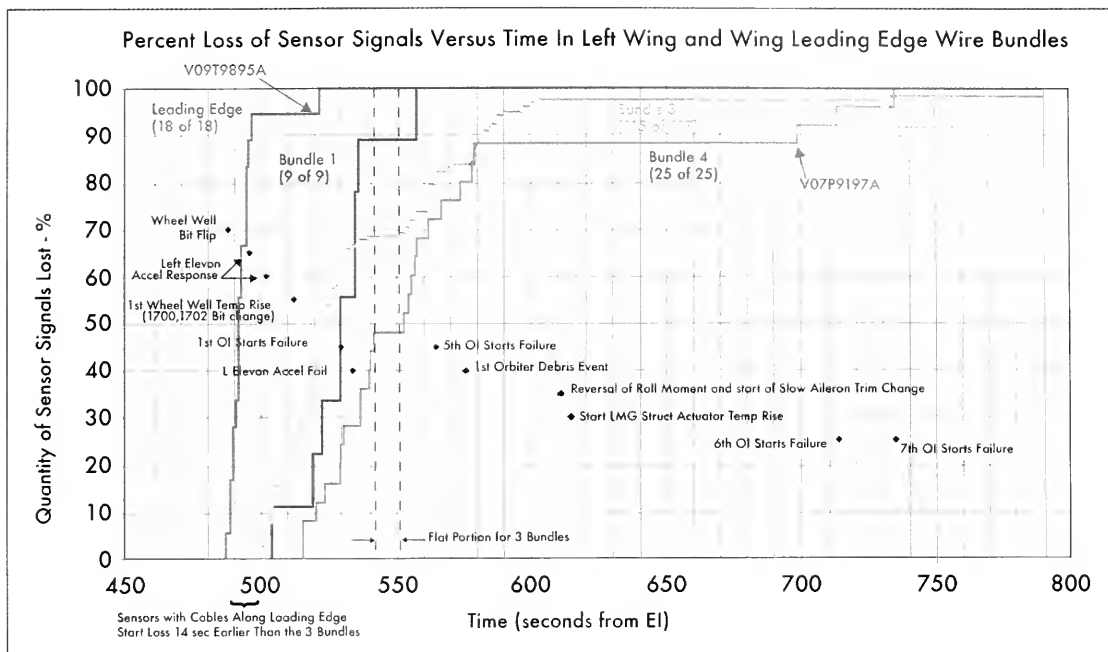
Fourteen seconds after the loss of the first sensor wire on the wing leading edge spar at EI+487, a sensor wire in a bundle of some 150 wires that ran along the upper outside corner of the left wheel well showed a burn-through. In the next 50 seconds, more than 70 percent of the sensor wires in three cables in this area also burned through (see Figure 3.6-10). Investigators plotted the wiring run for every left-wing sensor, looking for a relationship between their location and time of failure.

Figure 3.6-10. This chart shows how rapidly the wire bundles in the left wing were destroyed. Over 70 percent of the sensor wires in the wiring bundles burned through in under a minute. The black diamonds show the times of significant timeline sensor events.

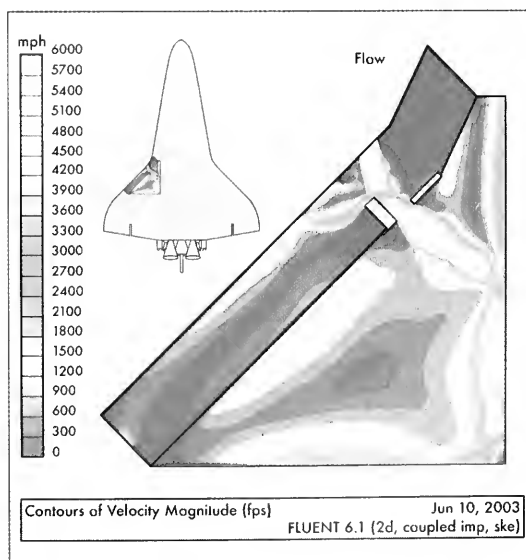
Later computational fluid dynamics analysis of the mid-wing area behind the spar showed that superheated air flowing into a breached RCC panel 8 and then interacting with the internal structure behind the RCC cavity (RCC ribs and spar insulation) would have continued through the wing leading edge spar as a jet, and would have easily allowed superheated air to traverse the 56.5 inches from the spar to the outside of the wheel well and destroy the cables (Figure 3.6-11). Controllers on the ground saw these first anomalies in the telemetry data at EI+613, when four hydraulic sensor cables that ran from the aft part of the left wing through the wiring bundles outside the wheel well failed.

Figure 3.6-11. The computational fluid dynamics analysis of the speed of the superheated air as it entered the breach in RCC panel 8 and then traveled through the wing leading edge spar. The darkest red color indicates speeds of over 4,000 miles per hour. Temperatures in this area likely exceeded 5,000 degrees Fahrenheit. The area of detail is looking down at the top of the left wing.

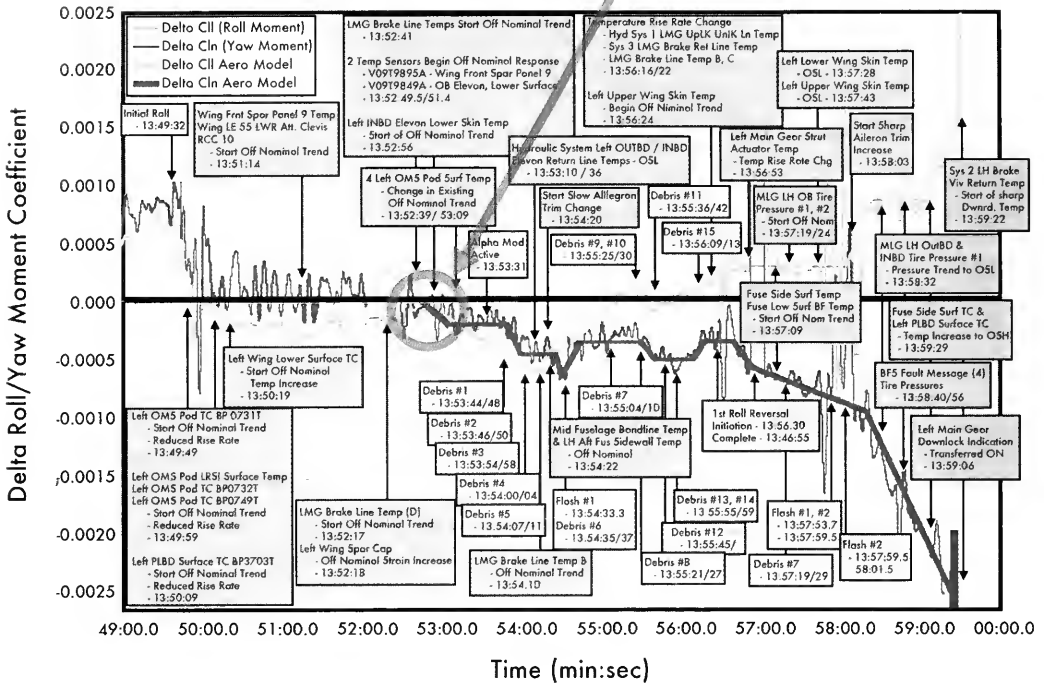
STS 107 Delta Rolling/Yawing Moment Coefficients
Off-Nominal Roll & Yaw

Aerodynamic roll and yaw forces began to differ from those on previous flights at about EI+500 (see Figure 3.6-12). Investigators used flight data to reconstruct the aerodynamic forces acting on the Orbiter. This reconstructed data was then compared to forces seen on other similar flights of *Columbia*

Figure 3.6-12. At approximately EI+500 seconds, the aerodynamic roll and yaw forces began to diverge from those observed from previous flights. The blue line shows the Orbiter's tendency to yaw while the red line shows its tendency to roll. Nominal values would parallel the solid black line. Above the black line, the direction of the force is to the right, while below the black line, the force is to the left.

and to the forces predicted for STS-107. In the early phase of flight, these abnormal aerodynamic forces indicated that *Columbia's* flight control system was reacting to a change in the external shape of the wing, which was caused by progressive RCC damage that caused a continuing decrease in lift and a continuing increase in drag on the left wing.

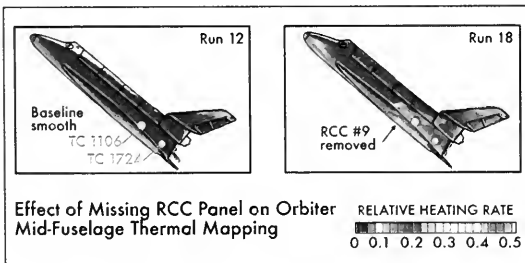
Figure 3.6-13. The effects of removing RCC panel 9 are shown in this figure. Note the brighter colors on the front of the OMS pod show increased heating, a phenomenon supported by both the OMS pod temperature sensors and the debris analysis.

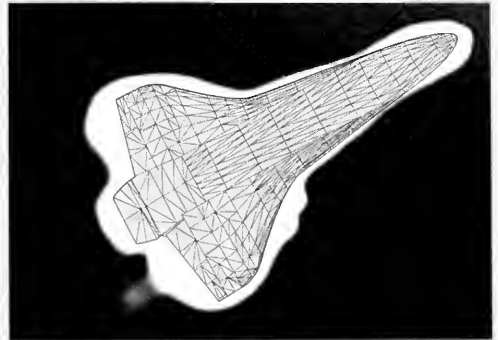
THE KIRTLAND IMAGE

As *Columbia* passed over Albuquerque, New Mexico, during re-entry (around EI+795), scientists at the Air Force Starfire Optical Range at Kirtland Air Force Base acquired images of the Orbiter. This imaging had not been officially assigned, and the photograph was taken using commercial equipment located at the site, not with the advanced Starfire adaptive-optics telescope.

The image shows an unusual condition on the left wing, a leading-edge disturbance that might indicate damage. Several analysts concluded that the distortion evident in the image likely came from the modification and interaction of shock waves due to the damaged leading edge. The overall appearance of the leading-edge damage at this point on the trajectory is consistent with the scenario.

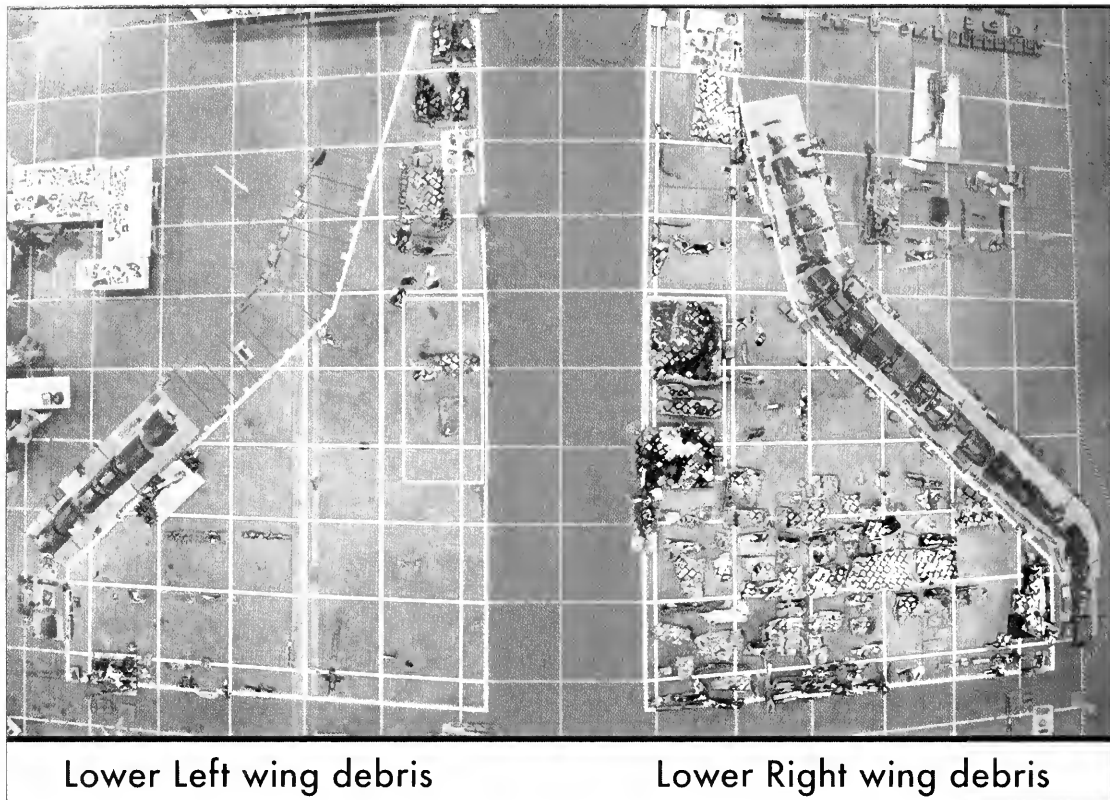
Figure 3.7-1. Comparison of amount of debris recovered from the left and right wings of Columbia. Note the amount of debris recovered from areas in front of the wheel well (the red boxes on each wing) were similar, but there were dramatic differences in the amount of debris recovered aft of each wheel well.

Detailed analysis of the debris revealed unique features and convincing evidence that the damage to the left wing differed significantly from damage to the right, and that significant differences existed in pieces from various areas of the left wing. While a substantial amount of upper and lower right wing structure was recovered, comparatively little of the upper and lower left wing structure was recovered (see Figure 3.7-1).

The difference in recovered debris from the Orbiter's wings clearly indicates that after the breakup, most of the left wing succumbed to both high heat and aerodynamic forces, while the right wing succumbed to aerodynamic forces only. Because the left wing was already compromised, it was the first area of the Orbiter to fail structurally. Pieces were exposed to higher heating for a longer period, resulting in more heat damage and ablation of left wing structural material. The left wing was also subjected to superheated air that penetrated directly into the mid-body of the wing for a substantial period. This pre-heating likely rendered those components unable to absorb much, if any, of the post-breakup heating. Those internal and external structures were likely vaporized during post-breakup re-entry. Finally, the left wing likely lost significant amounts of the Thermal Protection System prior to breakup due to the effect of internal wing heating on the Thermal Protection System bonding materials, and this further degraded the left wing's ability to resist the high heat of re-entry after it broke up.

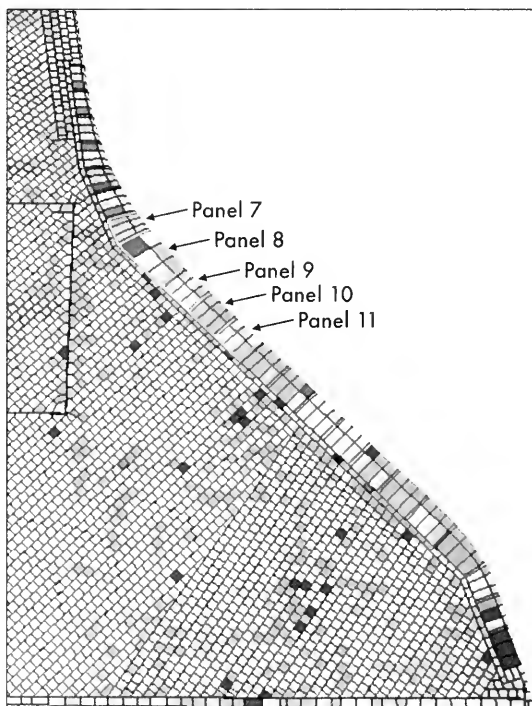
Figure 3.7-6. The tiles recovered farthest west all came from the area immediately behind left wing RCC panels 8 and 9. In the figure, each small box represents an individual tile on the lower surface of the left wing. The more red an individual tile appears, the farther west it was found.

An analysis of where tiles were found on the ground also yielded significant evidence of the breach location. Since most of the tiles are of similar size, weight, and shape, they would all have similar ballistic coefficients and would have behaved similarly after they separated from the Orbiter. By noting where each tile fell and then plotting its location on the Orbiter tile map, a distinctive pattern emerged. The tiles recovered farthest west all came from the area immediately behind the left wing RCC panel 8 and 9 (see Figure 3.7-6), which suggests that these tiles were released earlier than those from other areas of the left wing. While it is not conclusive evidence of a breach in this area, this pattern does suggest unique damage around RCC panels 8 and 9 that was not seen in other areas. Tiles from this area also showed evidence of a brown deposit that was not seen on tiles from any

other part of the Orbiter. Chemical analysis revealed it was an Inconel-based deposit that had come from inside the RCC cavity on the left wing (Inconel is found in wing leading edge attachment fittings). Since the streamlines from tiles with the brown deposit originate near left RCC panels 8 and 9, this brown deposit likely originated as an outflow of superheated air and molten metal from the panel 8 and 9 area.

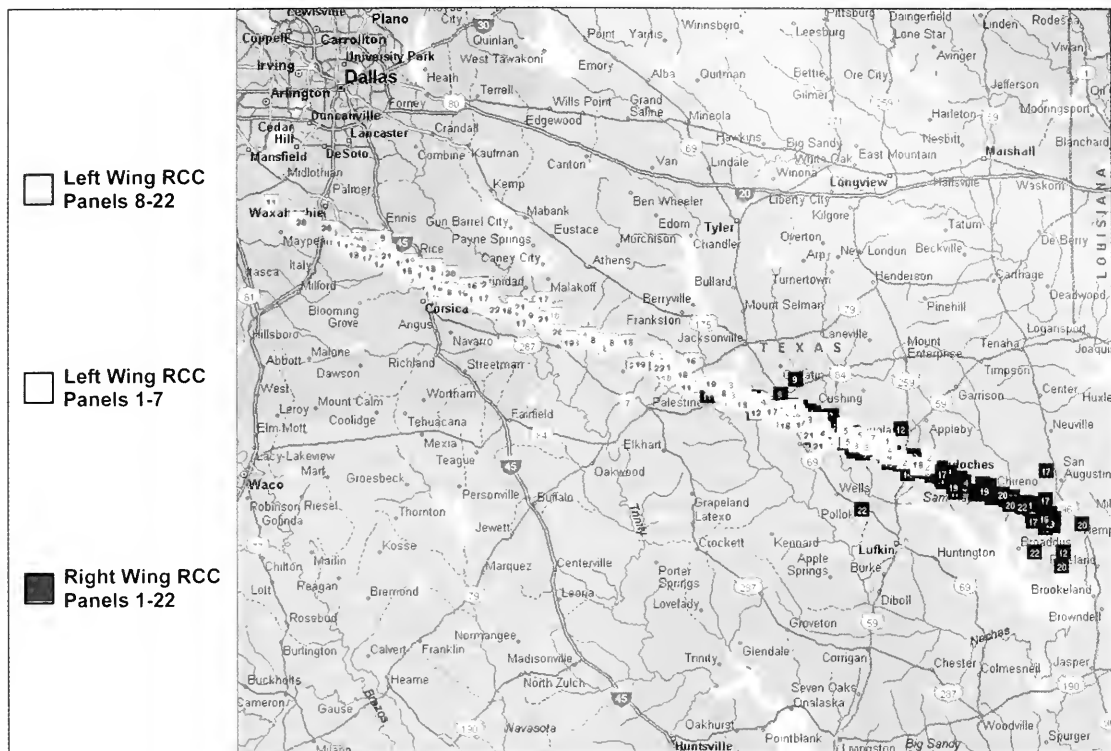
The location of debris on the ground also provided evidence of where the initial breach occurred. The location of every piece of recovered RCC was plotted on a map and labeled according to the panel the piece originally came from. Two distinct patterns were immediately evident. First, it was clear that pieces from left wing RCC panels 9 through 22 had fallen the farthest west, and that RCC from left wing panels 1 through 7 had fallen considerably farther east (see Figure 3.7-5). Second, pieces from left wing panel 8 were

Figure 3.7-5. The location of RCC panel debris from the left and right wings, shown where it was recovered from in East Texas. The debris pattern suggested that the left wing failed before the right wing, most likely near left RCC panels 8 and 9.

found throughout the debris field, which suggested that the left wing likely failed in the vicinity of RCC panel 8. The early loss of the left wing from RCC panel 9 and outboard caused the RCC from that area to be deposited well west of the RCC from the inboard part of the wing. Since panels 1 through 7 were so much farther to the east, investigators concluded that RCC panels 1 through 7 had stayed with the Orbiter longer than had panels 8 through 22.

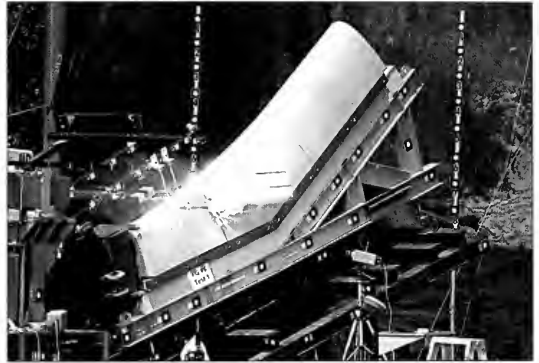
Figure 3.8-5. A typical foam strike leaves impact streaks, and the foam projectile breaks into shards and larger pieces. Here the foam is striking Panel 6 on a fiberglass test article.

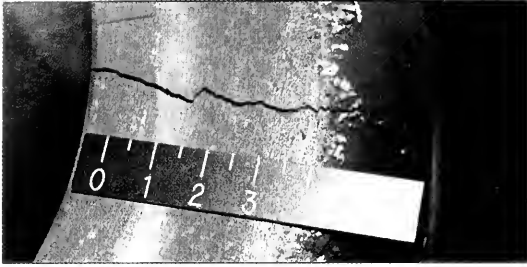
RCC panel 6 was tested first to begin to establish RCC impact response, although by the time of the test, other data had indicated that RCC panel 8-left was the most likely site of the breach. RCC panel 6 was impacted using the same parameters as the test on fiberglass panel 6 and developed a 5.5-inch crack on the outboard end of the panel that extended through the rib (see Figure 3.8-6). There was also a crack through the "web" of the T-seal between panels 6 and 7 (see Figure 3.8-7). As in the fiberglass test, the foam block deflected, or moved, the face of the RCC panel, creating a slit between the panel and the adjacent T-seal, which ripped the projectile and stuffed pieces of foam into the slit (see Figure 3.8-8). The panel rib failed at lower stresses than predicted, and the T-seal failed closer to predictions, but overall, the stress pattern was similar to what was predicted, demonstrating the need to incorporate more complete RCC failure criteria in the computational models.

Without further crack growth, the specific structural damage this test produced would probably not have allowed enough superheated air to penetrate the wing during re-entry to cause serious damage. However, the test did demonstrate that a foam impact representative of the debris strike at 81.9 seconds after launch could damage an RCC panel. Note that

Figure 3.8-6. A 5.5-inch crack on the outboard portion of RCC Panel 6 during testing.

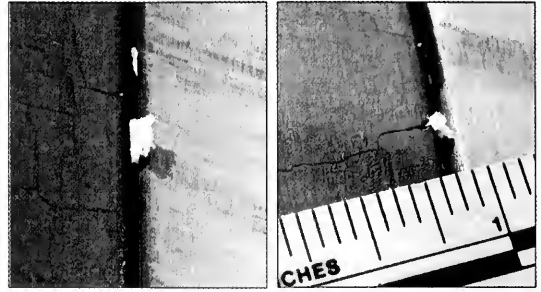
Figure 3.8-8. Two views of foam lodged into the slit during tests.

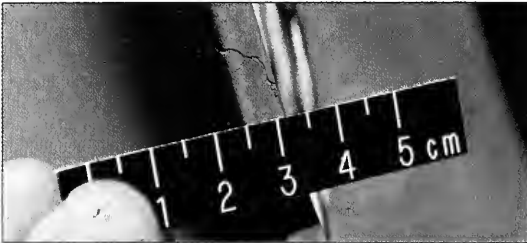
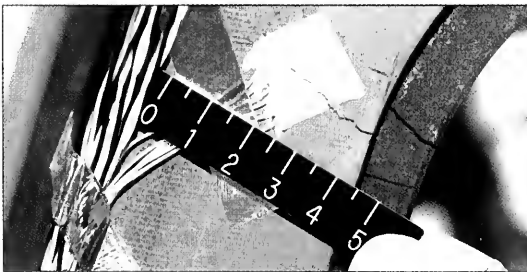
Figure 3.8-7. Two views of the crack in the T-seal between RCC Panels 6 and 7.

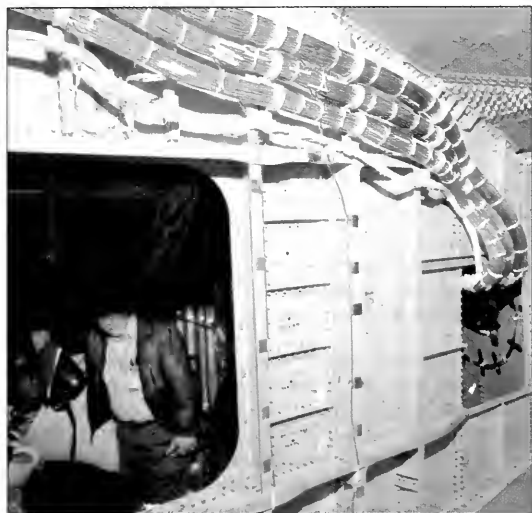
Figure 4.2-3. Typical wiring bundle inside Orbiter wing.

A typical wiring bundle is shown in Figure 4.2-3. Wiring nonconformances are corrected by rerouting, reclamping, or installing additional insulation such as convoluted tubing, insulating tape, insulating sheets, heat shrink sleeving, and abrasion pads (see Figure 4.2-4). Testing has shown that wiring bundles usually stop arc tracking when wires are physically separated from one another. Further testing under conditions simulating the Shuttle's wiring environment demonstrated that arc tracking does not progress beyond six inches. Based on these results, Boeing recommended that NASA separate all critical paths from larger wire bundles and individually protect them for a minimum of six inches beyond their separation points.⁴ This recommendation is being adopted through modifications performed during scheduled Orbiter Major Modifications. For example, analysis of telemetered data from 14 of *Columbia's* left wing sensors (hydraulic line/wing skin/wheel temperatures, tire pressures, and landing gear downlock position indication) provided failure signatures supporting the scenario of left-wing thermal intrusion, as opposed to a catastrophic failure (extensive arc tracking) of Kapton wiring. Actual NASA testing in the months following the accident, during which wiring bundles were subjected to intense heat (ovens, blowtorch, and arc jet), verified the failure signature analyses. Finally, extensive testing and analysis in years prior to STS-107 showed that, with the low currents and low voltages associated with the Orbiter's instrumentation system (such as those in the left wing), the probability of arc tracking is commensurately low.

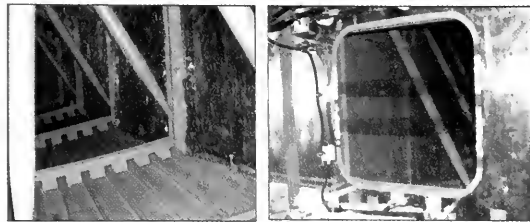
Figure 4.2-5. At left, a wing section open for inspection; at right, wing access closed off after inspection.

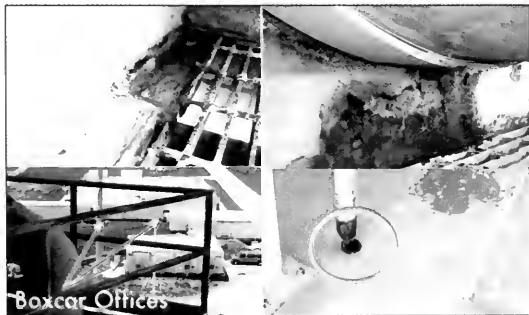
Board investigators have identified deteriorating infrastructure associated with the launch pads, Vehicle Assembly Building, and the crawler transporter. Figures 5.5-5 and 5.5-6 depict some of this deterioration. For example, NASA has installed nets, and even an entire sub-roof, inside the Vehicle Assembly Building to prevent concrete from the building’s ceiling from hitting the Orbiter and Shuttle stack. In addition, the corrosion-control challenge results in zinc primer

on certain launch pad areas being exposed to the elements. When rain falls on these areas, it carries away zinc, runs onto the leading edge of the Orbiter’s wings, and causes pinholes in the Reinforced Carbon-Carbon panels (see Chapter 3).

Figure 5.5-5 and 5.5-6. Examples of the seriously deteriorating infrastructure used to support the Space Shuttle Program. At left is Launch Complex 39A, and at right is the Vehicle Assembly building, both at the Kennedy Space Center.

In Fiscal Year 2002, Congress added \$25 million to NASA’s budget for Vehicle Assembly Building repairs. NASA has reallocated limited funds from the Shuttle budget to pressing infrastructure repairs, and intends to take an integrated look at infrastructure as part of its new Shuttle Service Life Extension Program. Nonetheless, like Space Shuttle upgrades, infrastructure revitalization has been mired by the uncertainty surrounding the Shuttle Program’s lifetime. Considering that the Shuttle will likely be flying for many years to come, NASA, the White House, and Congress alike now face the specter of having to deal with years of infrastructure neglect.

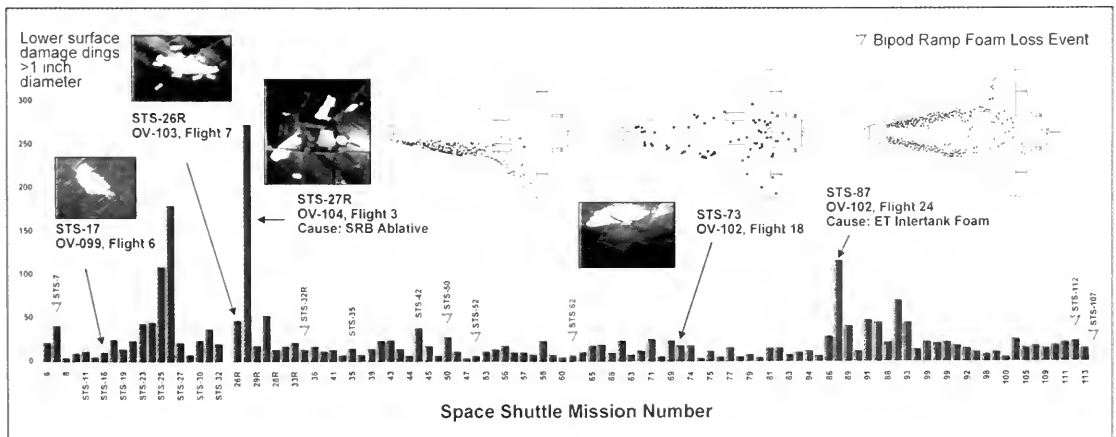
Figure 6.1-6. This chart shows the number of dings greater than one inch in diameter on the lower surface of the Orbiter after each mission from STS-6 through STS-113. Flights where the bipod ramp foam is known to have come off are marked with a red triangle.

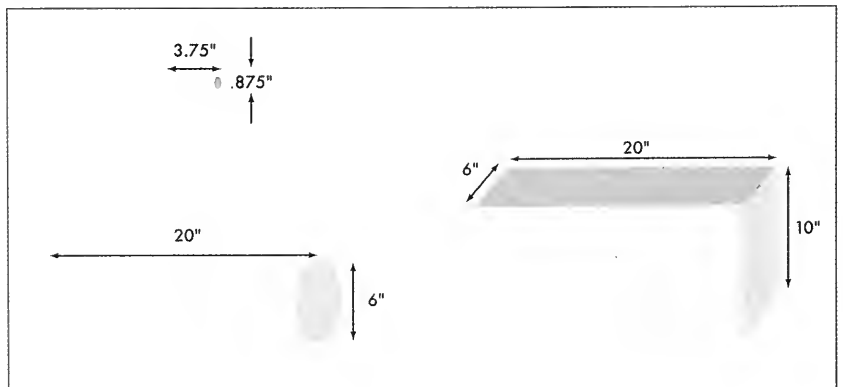
To calculate the damage that might result from such a strike, the analysts turned to a Boeing mathematical modeling tool called Crater that uses a specially developed algorithm to predict the depth of a Thermal Protection System tile to which debris will penetrate. This algorithm, suitable for estimating small (on the order of three cubic inches) debris impacts, had been calibrated by the results of foam, ice, and metal debris impact testing. A similar Crater-like algorithm was also developed and validated with test results to assess the damage caused by ice projectiles impacting the RCC leading edge panels. These tests showed that within certain limits, the Crater algorithm predicted more severe damage than was observed. This led engineers to classify Crater as a "conservative" tool – one that predicts more damage than will actually occur.

Until STS-107, Crater was normally used only to predict whether small debris, usually ice on the External Tank, would pose a threat to the Orbiter during launch. The use of Crater to assess the damage caused by foam during the launch of STS-107 was the first use of the model while a mission was on orbit. Also of note is that engineers used Crater during STS-107 to analyze a piece of debris that was at maximum 640 times larger in volume than the pieces of debris used to calibrate and validate the Crater model (the Board's best estimate is that it actually was 400 times larger). Therefore, the use of Crater in this new and very different situation compromised NASA's ability to accurately predict debris damage in ways that Debris Assessment Team engineers did not fully comprehend (see Figure 6.3-1).

Figure 6.3-1. The small cylinder at top illustrates the size of debris Crater was intended to analyze. The larger cylinder was used for the STS-107 analysis; the block at right is the estimated size of the foam.
